Sub- Annual certification of operational dyke and Fly ash Generation and Utilization report for the year 2024-25

With reference to the above cited subject for 2 x600MW Thermal Power Plant located at Badadarha, Chhattisgarh, Please find the attached:

Sponsored by

D B Power Limited

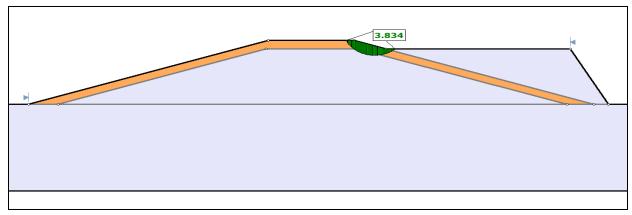
Figure 6 (a): Critical slip surface, *Divide Bund* (Dry condition)

Dry condition	3.83
Saturated condition	3.74
Seismic condition	2.43

From Table 3, it can be seen that this section is found to be stable for all the loading conditions studied, as FOS values are above the reference value of 1.5 for long term stability.

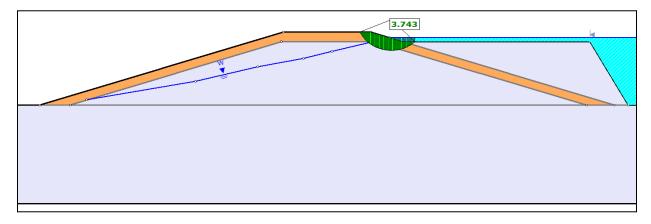
Figure 6 (b): Critical slip surface, *Divide Bund* (Saturated condition)

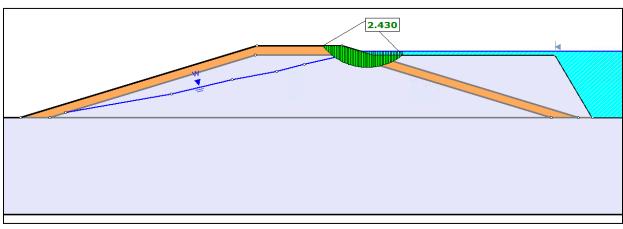
Figure 6 (c): Critical slip surface, *Divide Bund* (Seismic condition)

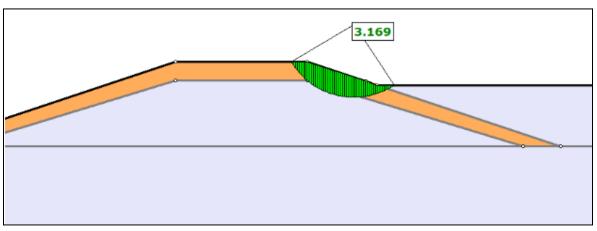
Figure 8 (a): Critical slip surface, East Side Bund (Dry condition)

From Table 4, it can be seen that this section is found to be stable for all the loading conditions studied, as FOS values are above the reference value of 1.5 for long term stability.

Dry condition	3.17
Saturated condition	2.79
Seismic condition	1.94

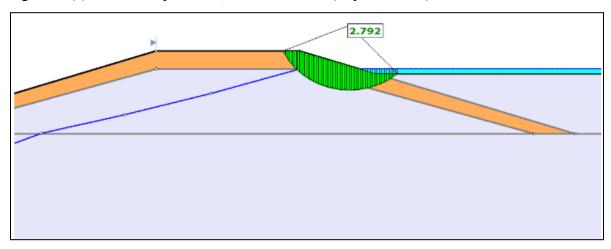
Figure 8 (b): Critical slip surface, *East Side Bund* (Saturated condition)

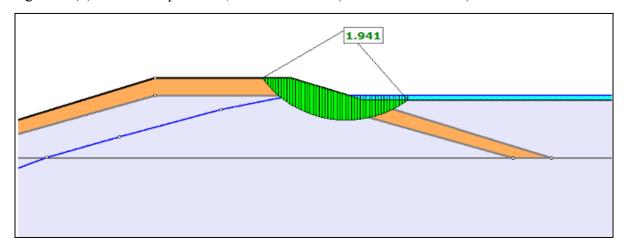
Figure 8 (c): Critical slip surface, East Side Bund (Seismic condition)

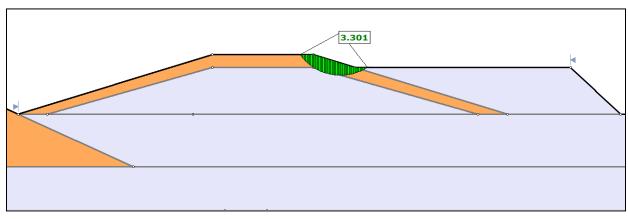
Figure 10(a): Critical slip surface, North Side Bund (Dry condition)

From Table 5, it can be seen that this section is found to be stable for all the loading conditions studied, as FOS values are above the reference value of 1.5 for long term stability.

Dry condition	3.30
Saturated condition	3.02
Seismic condition	2.55

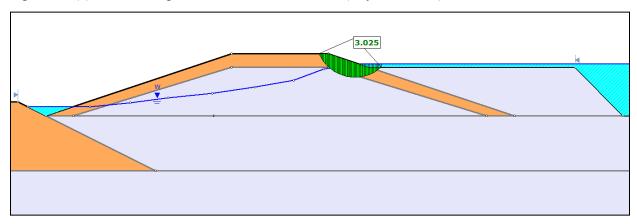
Figure 10(b): Critical slip surface, *North Side Bund* (Saturated condition)

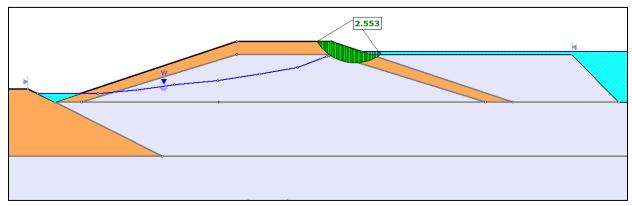
Figure 10(c): Critical slip surface, North Side Bund (Seismic condition)

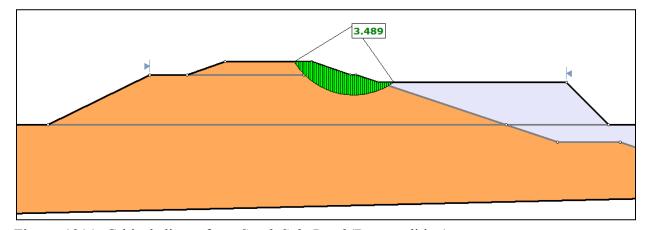
Figure 12(a): Critical slip surface, *South Side Bund* (Dry condition)

From Table 6, it can be seen that this section is found to be stable for all the loading conditions studied, as FOS values are above the reference value of 1.5 for long term stability.

Dry condition	3.49
Saturated condition	3.48
Seismic condition	2.65

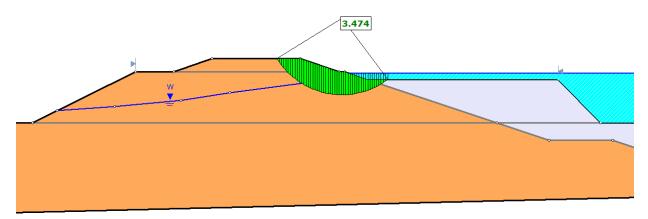
Figure 12(b): Critical slip surface, South Side Bund (Saturated condition)

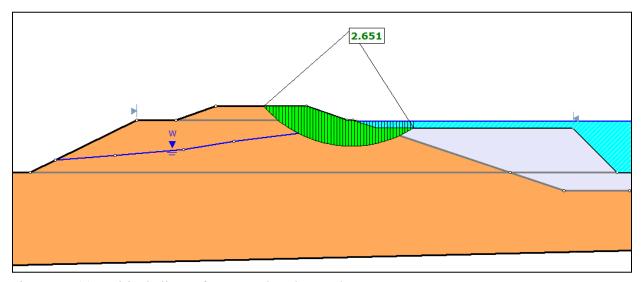
Figure 12(c): Critical slip surface, *South Side Bund* (Seismic condition)

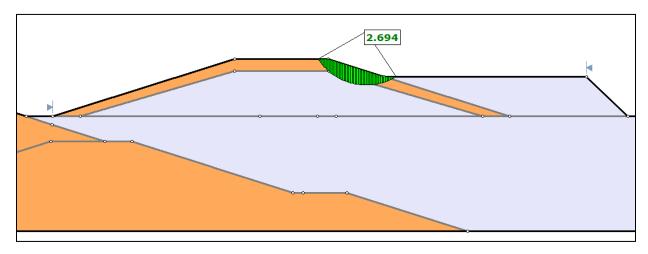
Figure 14(a): Critical slip surface, West Side Bund of Lagoon 1 (Dry condition)

From Table 7, it can be seen that this section is found to be stable for all the loading conditions studied, as FOS values are above the reference value of 1.5 for long term stability.

Dry condition	2.69
Saturated condition	2.42
Seismic condition	1.69

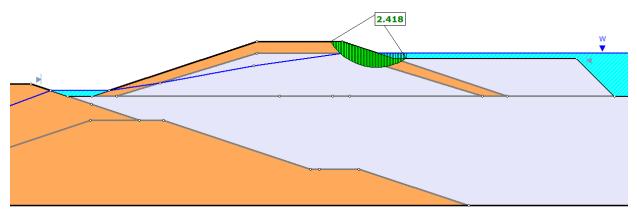
Figure 14(b): Critical slip surface, West Side Bund of Lagoon 1 (Saturated condition)

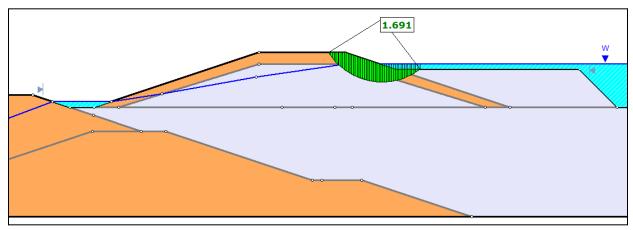
Figure 14(c): Critical slip surface, West Side Bund of Lagoon 1 (Seismic condition)

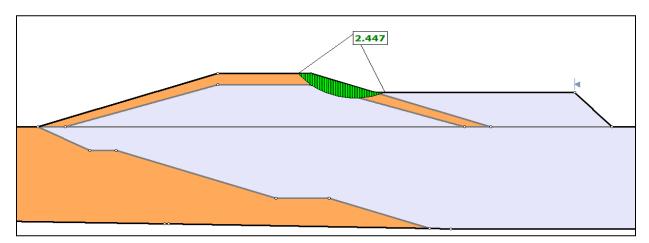
Figure 16(a): Critical slip surface, West Side Bund of Lagoon 2 (Dry condition)

From Table 8, it can be seen that this section is found to be stable for all the loading conditions studied, as FOS values are above the reference value of 1.5 for long term stability.

Dry condition	2.45
Saturated condition	2.15
Seismic condition	1.95

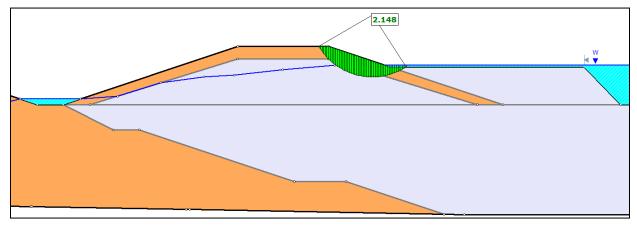
Figure 16(b): Critical slip surface, West Side Bund of Lagoon 2 (Saturated condition)

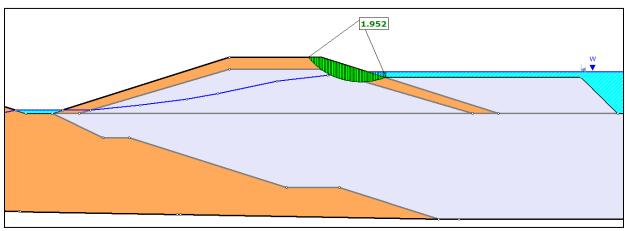
Figure 16(c): Critical slip surface, West Side Bund of Lagoon 2 (Seismic condition)

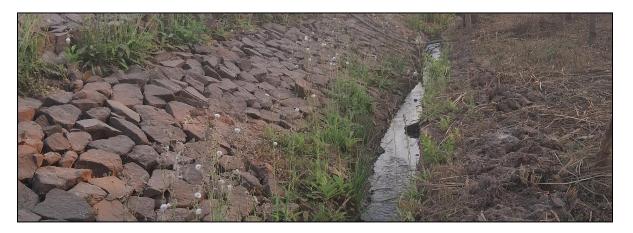
Figure 17: Rock Toe and Toe Drain. Rock toe the materials size from 10 to 250 cm; and toe drain width 500 mm and depth 400 mm.

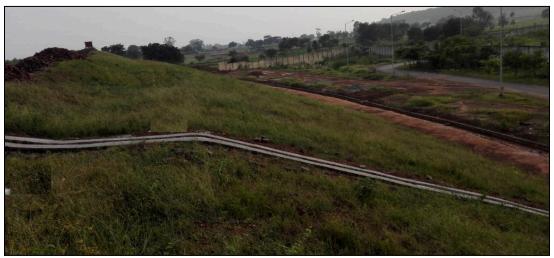
Figure 18: Slope Drain and D/S side slop Cover with Turfing. Rectangular strips of uniform width, not less than about 25 cm x 30 cm in size.

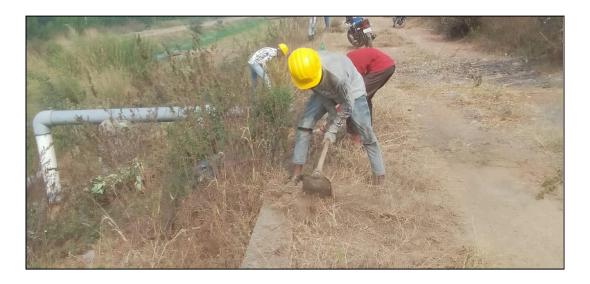
Figure 19: U/S Side Brick lining and Dowel bank. Size - depth 200 mm and wide 100 mm.

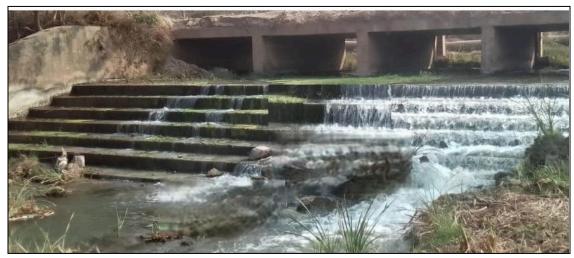
As per stormy rains were observed many times at site but flow of surface runoff through the existing spillways was not seen. Entire runoff was passing through openings of the decantation well.

Spillway outlet trough is well connected with settling tank existing in the North of Lagoon#1. Thus existing spillways are very much capable of passing surface runoff safely without any danger to ash dyke embankment.

Figure 21: Spillway size 10 m x 6 m x1 m

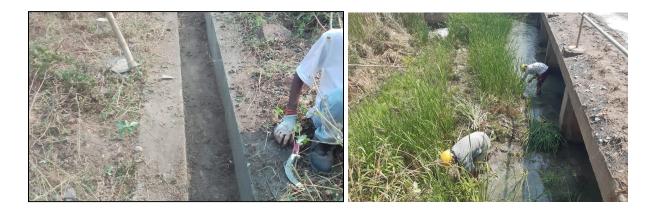
V	Vegetation in Toe Drains	Vegetation growth was observed in the toe drains, particularly during the monsoon season.	Regular cleaning and maintenance of the toe drains are now in place to avoid blockages
VI	Vegetation in Slope Drains	Vegetation build-up was found in the slope drains during the rainy period, hindering water flow	Slope drains are being cleared periodically to maintain proper functionality.
VII	Condition of Spillway	Vegetation growth was observed on the steps of the spillway during rainy conditions, affecting its efficiency.	Periodic cleaning of the spillway is being carried out to ensure its proper operation during rains.
VIII	U/S Side of Ash Dyke	Erosion and surface instability were observed on the u/s side of the ash dyke.	Brick pitching has been installed on the u/s side of the ash dyke to improve stability and prevent further erosion.
IX	D/S Side of Ash Dyke	Erosion and insufficient vegetation cover were noted on the d/s side of the ash dyke.	Turfing has been completed on the d/s side to strengthen the soil and prevent erosion.

Figure 27(g): Cleaning of slope drains
