Sub- Annual certification of operational dyke and Fly ash Generation and Utilization report for the year 2024-25

With reference to the above cited subject for 2 x600MW Thermal Power Plant located at Badadarha, Chhattisgarh, Please find the attached:

Sponsored by

D B Power Limited

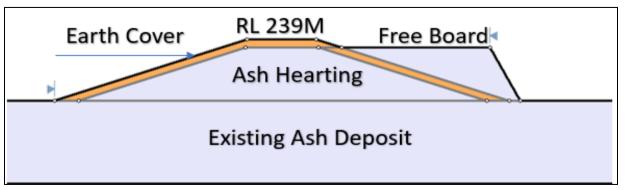
Figure 5: cross-section of Divide Bund

Figure 5 presents the section along Divide Bund and the corresponding model geometry for numerical analysis using Slide2 software tool, respectively. The resulting failure surface and the corresponding FOS value for each of the aforementioned conditions are presented in Figures 6(a) to 6(c) and Table 3, respectively.

Dry condition	3.83
Saturated condition	3.74
Seismic condition	2.43

From Table 3, it can be seen that this section is found to be stable for all the loading conditions studied, as FOS values are above the reference value of 1.5 for long term stability.

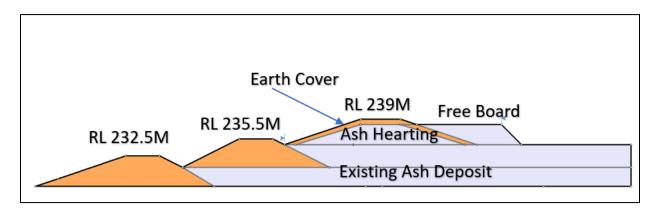
Figure 9: cross-section Along of North Side Bund

Figure 9 presents the section Along North Side Bund and the corresponding model geometry for numerical analysis using Slide2 software tool, respectively. The resulting failure surface and the corresponding FOS value for each of the above conditions are presented in Figures 10(a) to 10(c) and Table 5, respectively.

Dry condition	3.30
Saturated condition	3.02
Seismic condition	2.55

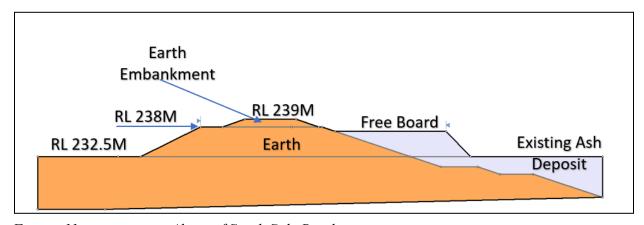
Figure 11 cross-section Along of South Side Bund

Figure 11 presents the section Along South Side Bund and the corresponding model geometry for numerical analysis using Slide2 software tool, respectively. The resulting failure surface and the corresponding FOS value for each of the above conditions are presented in Figures 12(a) to 12(c) and Table 6, respectively.

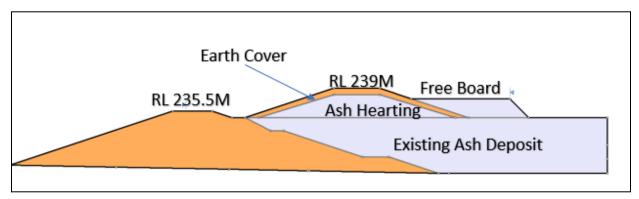
Figure 15: cross-section Along West Side Bund of Lagoon 2

Figure 15 presents the section Along West Side Bund of Lagoon 2 and the corresponding model geometry for numerical analysis using Slide2 software tool, respectively. The resulting failure surface and the corresponding FOS value for each of the above conditions are presented in Figures 16(a) to 16(c) and Table 8, respectively.

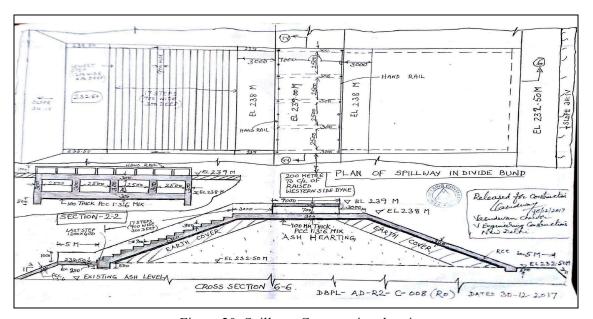
Figure 20: Spillway Construction drawing

As per stormy rains were observed many times at site but flow of surface runoff through the existing spillways was not seen. Entire runoff was passing through openings of the decantation well.

Spillway outlet trough is well connected with settling tank existing in the North of Lagoon#1. Thus existing spillways are very much capable of passing surface runoff safely without any danger to ash dyke embankment.
